Remediation Statement

Former Singers Tip, Kilbowie Road, Clydebank

Part IIA Environmental Protection Act 1990

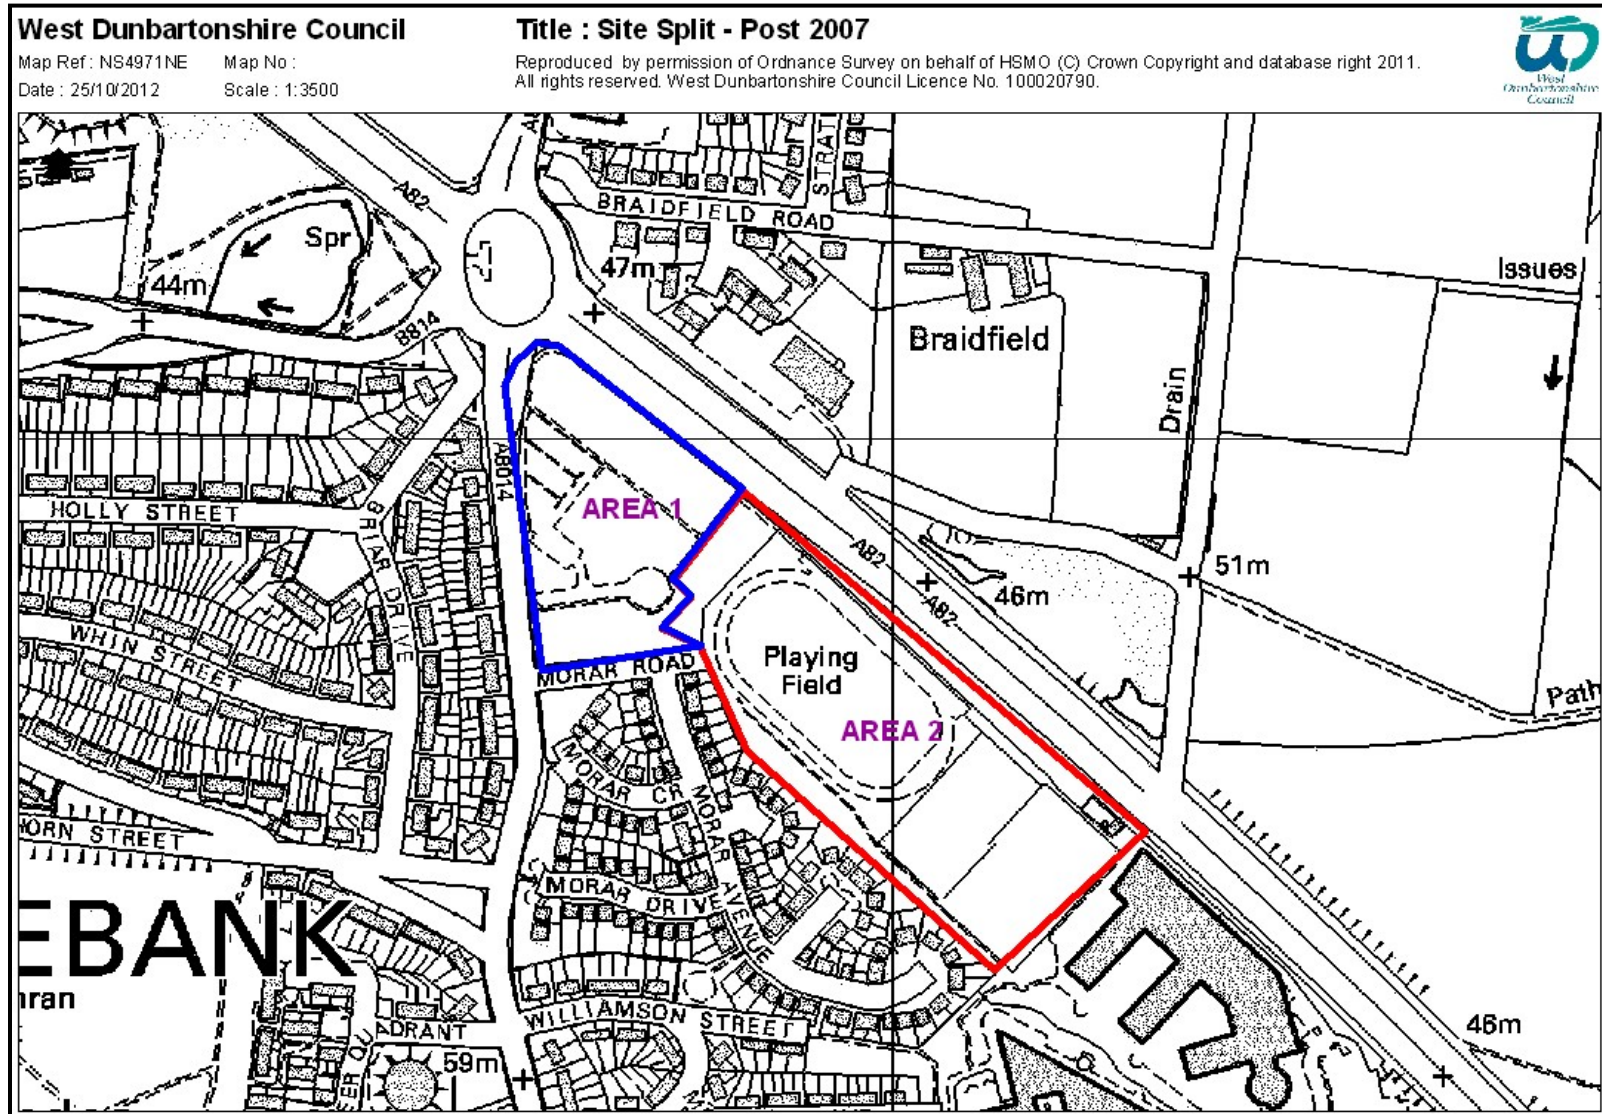
APPENDIX 2: SITE SPLIT POST 2007

- 4.1 In 2007, and as part of the WDC Schools PPP Initiative, a planning application for a new school was submitted which included plans to utilise some of the Part IIA site for the school sports pitches. The site was then divided into two (see Appendix 2). As a result two separate remediation schemes were submitted, a summary of which is detailed in Section 6 and Section 7 of this report.
- 4.2 The south eastern portion of the site (Area 2) occupying approximately 4Ha is currently utilised for the school sports pitches associated to the St Peter the Apostle High School. The north western portion of the site (Area 1) occupying approximately 1.6Ha is currently utilised as a car park with a bus turning circle for school pick up/drop off. Both sites are linked by way of a footpath to enable easier access to the school from the neighbouring properties to the west.
