**DUMBARTON TOWN CENTRE  
CONSERVATION AREA APPRAISAL**

fiona **sinclair** architect

April 2023

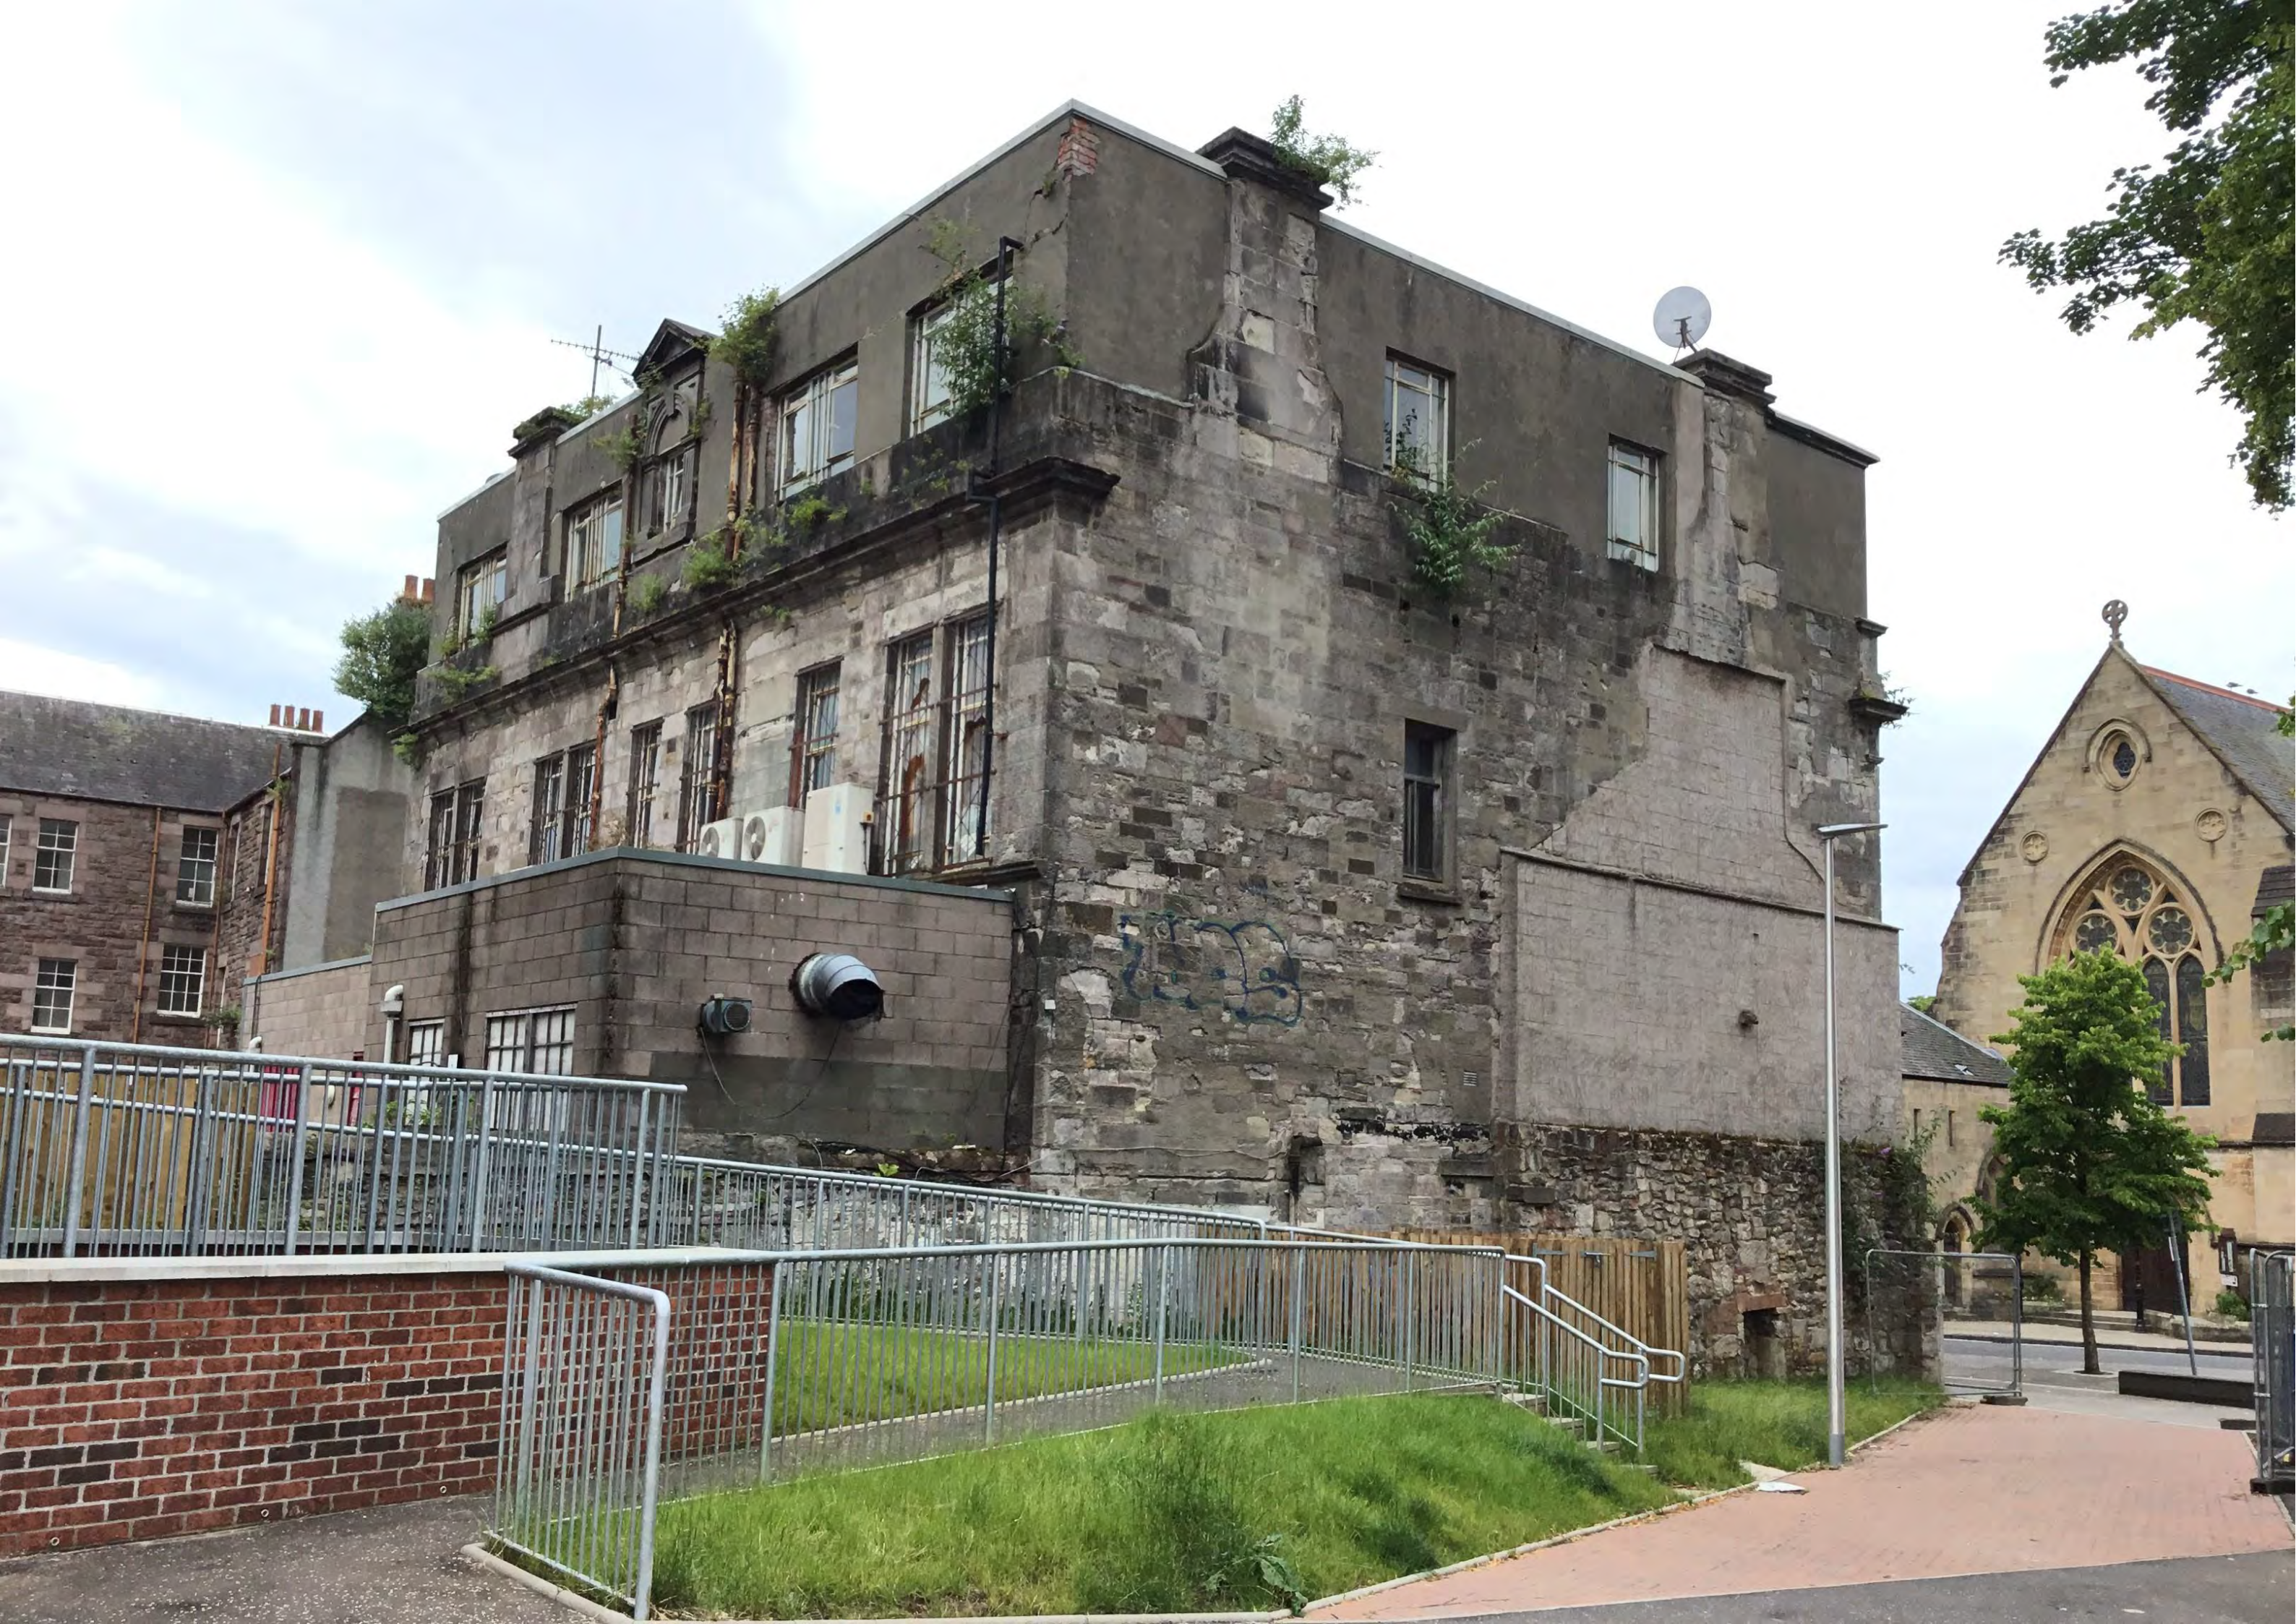
Left: Although there has been investment in the public realm on High Street, and the setting to St. Augustine's Church is good, No. 3 High Street is in especially poor condition and requires intervention (© author).

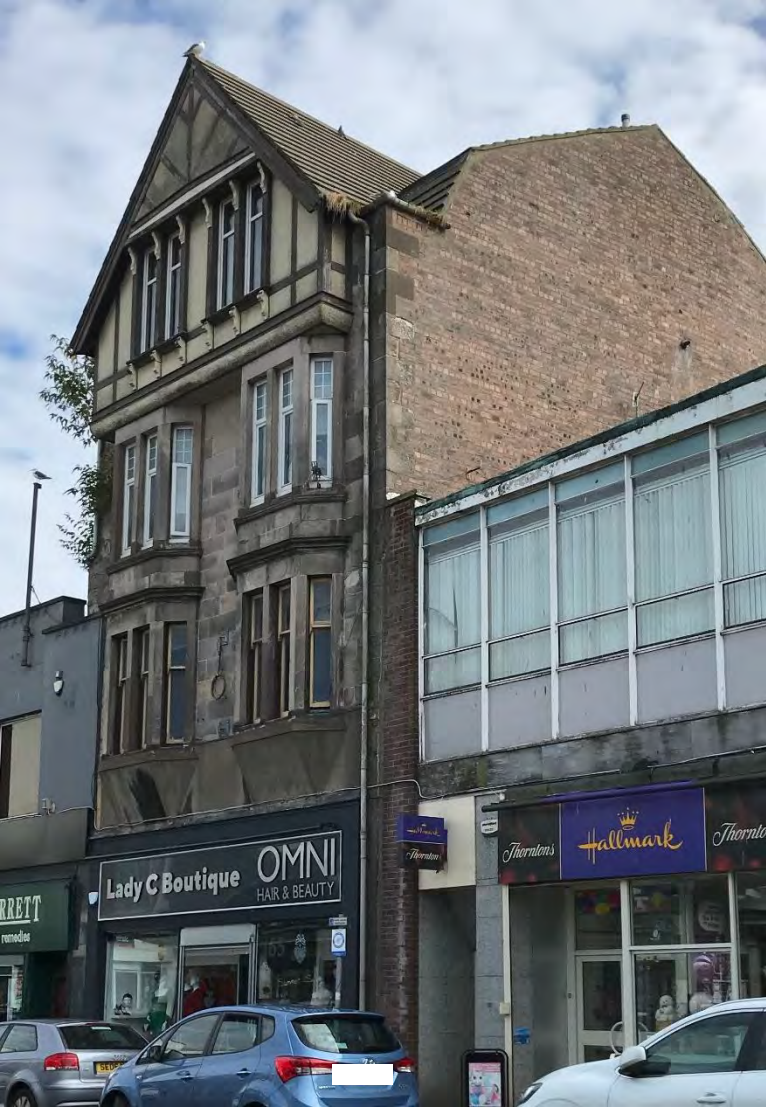
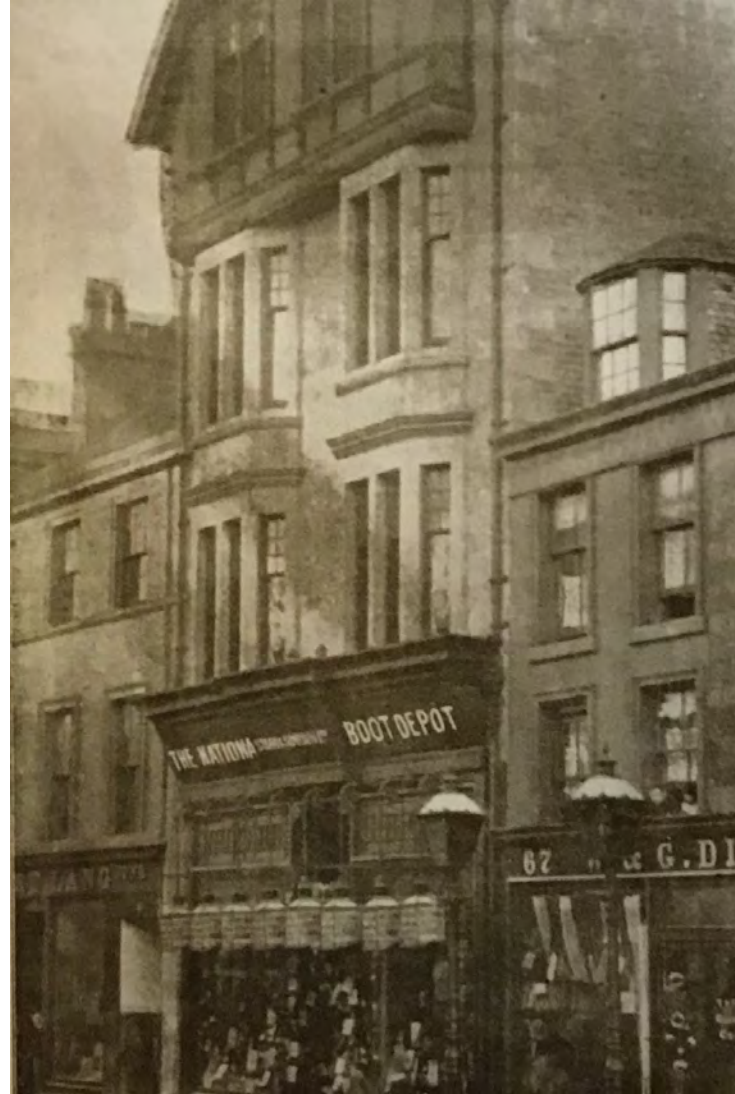
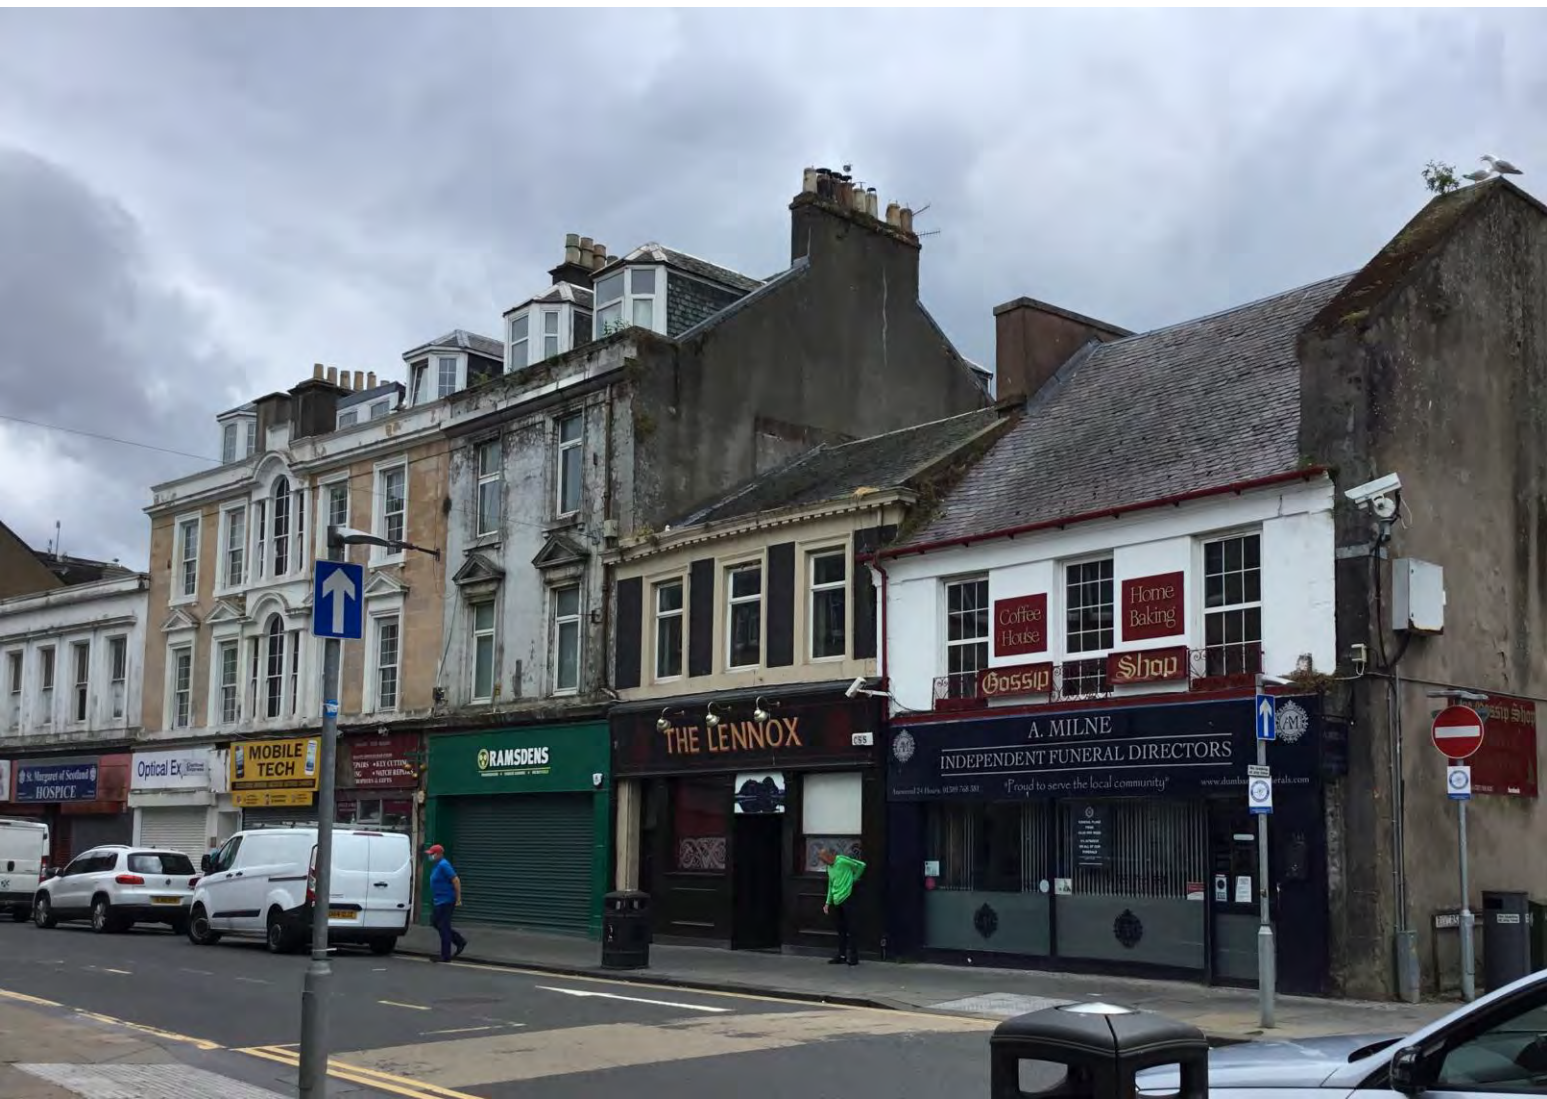
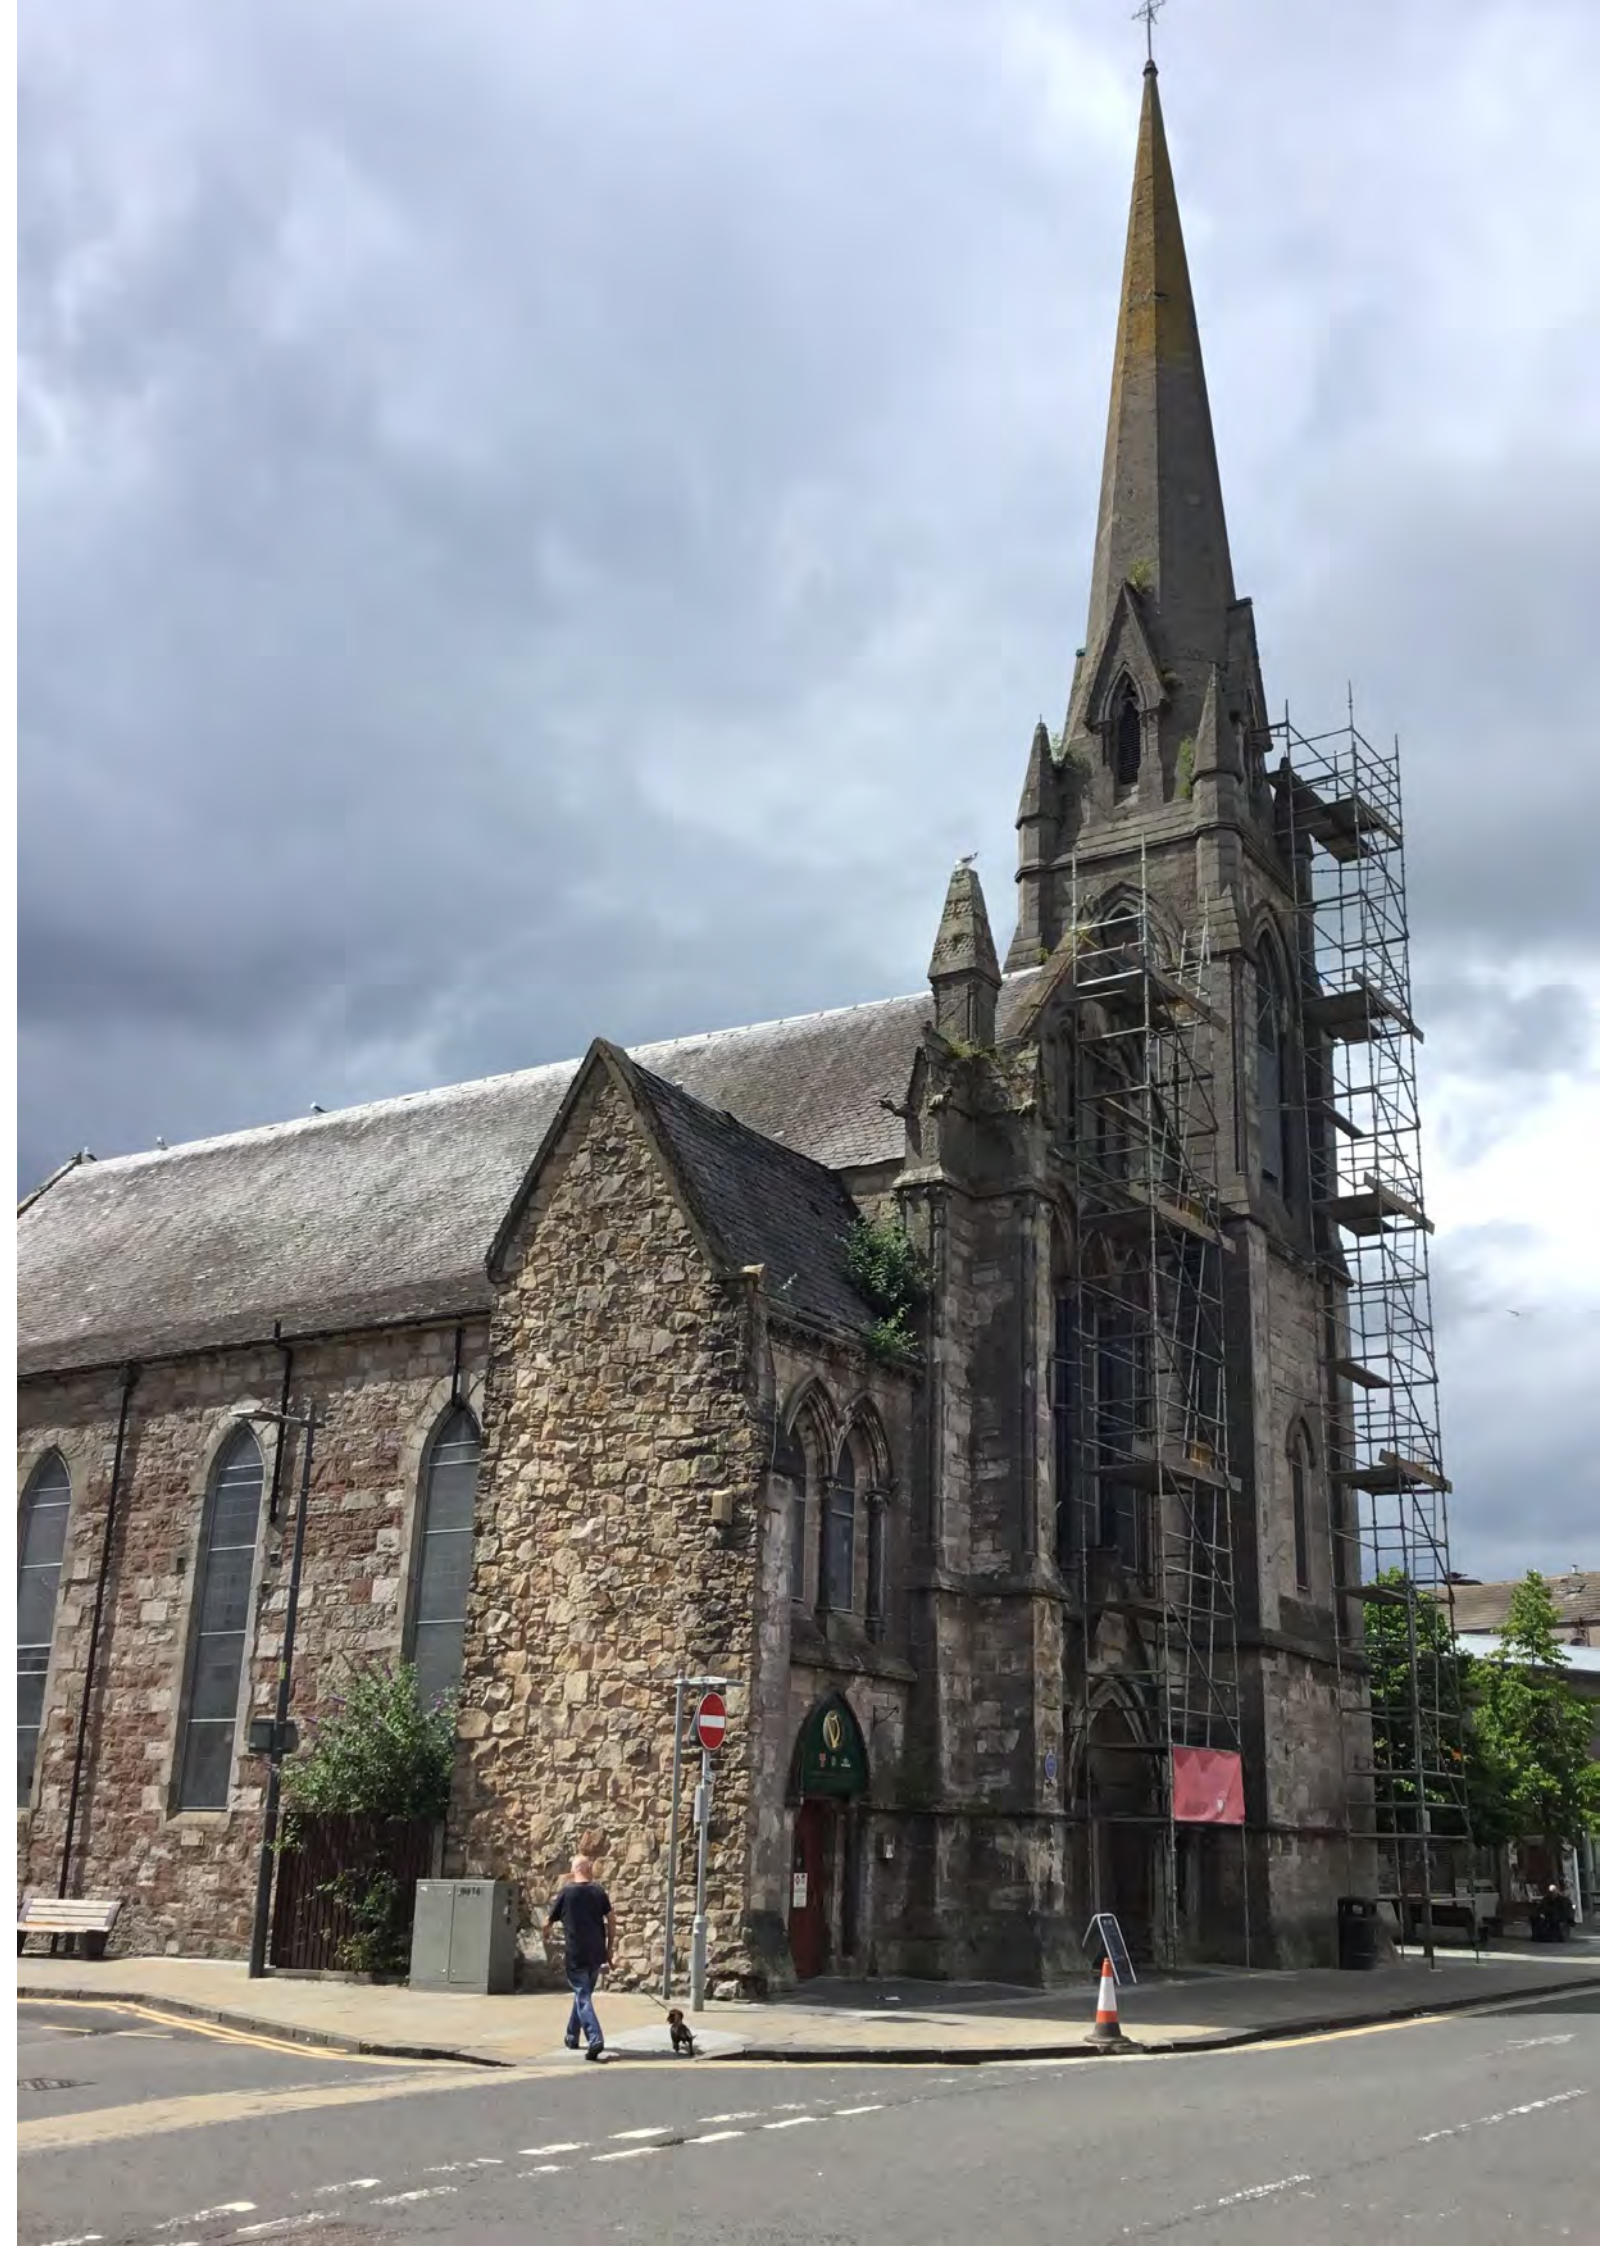
Buildings in the ownership of the church and local authority are in uniformly good condition, but those in private or mixed ownership are variable. There is a preponderance of buddleia growing from roofs and walls on High Street, and much building fabric in need of attention. There are three buildings on High Street on the *Buildings at Risk Register*, including the former Hiram Walker headquarters at No. 3. Added in September 2021, the entry draws attention to the vacancy, established vegetation growth, spalling render to the rear, delamination of stone, cracking, and failed rainwater goods. At Nos. 119-123 High Street, issues of vacancy and dampness are highlighted (including the poor condition to the rear), and at Nos. 125-133 High Street peeling paint, potential parapet gutter failure and upper floor vacancy are noted. The service yard behind Nos. 119-123 is disused, and a large sycamore has been allowed to grow too close to the brick boundary wall, which is showing signs of movement.

The former Hiram Walker headquarters (originally the McMillan Shipyard offices and more recently the offices of the Procurator Fiscal and then a public house) is in particularly poor condition, with roosting pigeons, distortion in the metal windows, an ugly attic storey, and a redundant conservatory to the west in the gap next to the former British Linen Company Bank. Nor is this second building in a well-maintained state, with failed (cracked) rainwater goods, and extensive vegetation growth (including grass growing from gutters). There is efflorescence and biological growth on the main frontage, both hallmarks of a chemical clean of the stone in the past (or the application of water repellent). Few of the building façades on the south side of High Street have been left unpainted: paint on ashlar conventionally traps moisture (as well as hiding other defects) and peeling paint is evident at a number of locations. At No. 53, the former Clydesdale Bank, the paint is likely to have been particularly damaging (not to mention currently unattractive), and the stepped parapet has extensive plant growth in the joints.

1895 design for the National Boot Depot), and a veritable (unintentional) roof garden at cornice level on the former Claude Alexander building (now Costa). At the former Burtons, on the corner of Quay Street, there are small ferns growing from the joints in the faience. Further west, there appears to be gutter failure and some cracking at No. 107 (most of the High Street properties have internal rainwater goods, some of which may be blocked), Nos. 119-123 appear to have been vacated, and building repairs at Nos. 125-133 are not quite complete. Next door, at No. 135, crazing on the frontage is suggestive of a failing cement skim on the stonework. The diminutive two-storey public house at No. 139 may have a snapped window lintel since the mutilated eaves cornice droops at the east, while No. 141 has an untidy slate roof (particularly on the rear turnpike stair) and badly finished gable. As the Conservation Area boundary is reached to the west, the former High Church, now Bell Centre, has a range of defects typical of a large building with inaccessible tower, and an especially ugly gable where a tenement once adjoined.

The condition on the north side of High Street is better, although the large red sandstone tenement at Nos. 84-92 is water damaged. Nos. 16-20, once home to the London and Newcastle Tea Company, has deteriorating attic dormers and much damaging cement pointing to the rear (in common with No. 22), while the roof to Nos. 8-10 is uneven (and the plastic rainwater goods to the front an addition). Nos. 2-6 (dated 1880?) have been recently and reasonably well restored, the armorial carvings on the street front worn but still legible. On Castle Street, the attractive three-storey tenements (c1885) turning onto Church Street are exhibiting stonework erosion, and there is a truncated wallhead chimney at No. 2 Church Street. Nos. 3-13 Castle Street are elegant but with loss of stonework detail; the soft red sandstone to the rear elevation has also been patched with cement.

Clockwise from top left: The former National Boot Depot on High Street has a great deal of buddleia growth at high level and a poor shopfront (© author); the building (by J M Crawford) not long after construction showing the original shop frontage (© West Dunbartonshire Libraries); the former High Church (now Bell Centre) has an unfortunate exposed gable and is in need of repair (© author); building condition is variable (and in some instances poor) on the south side of High Street (© author).

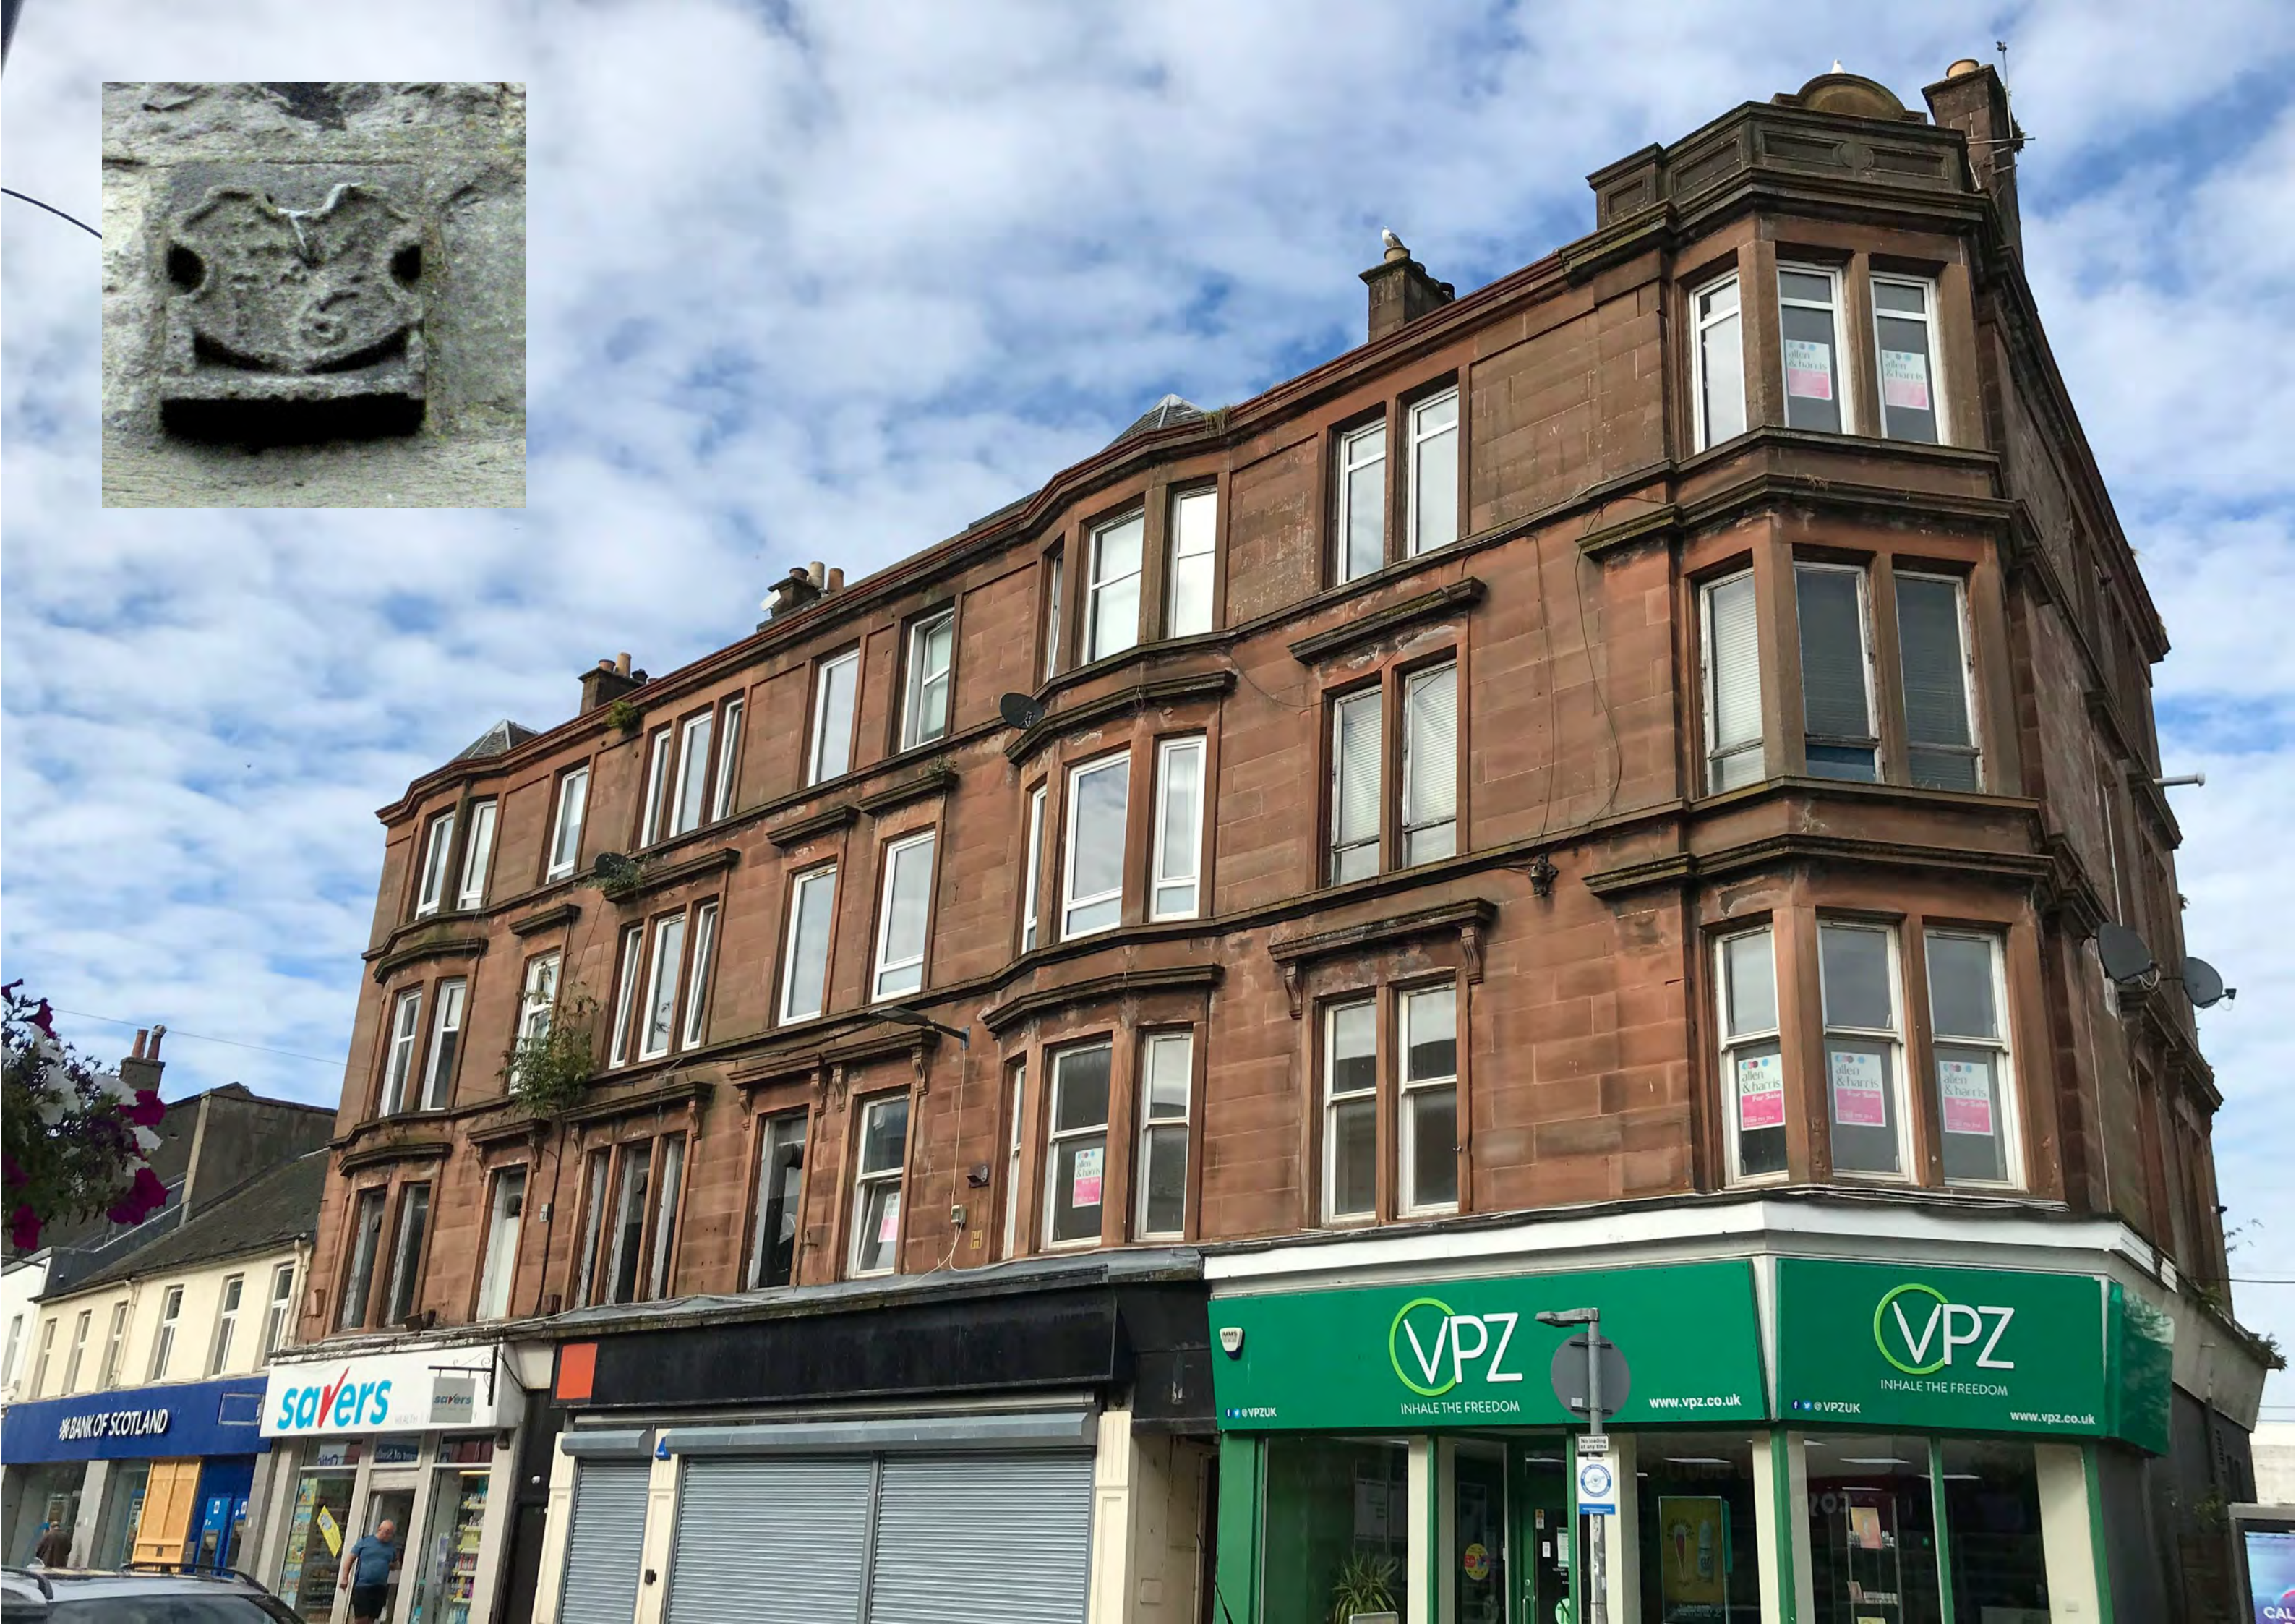
Original architectural detail makes a defining contribution to the character and appearance of any Conservation Area. Retention and repair are therefore important aspects of the preservation and enhancement of an area. Conversely, inappropriate replacement windows and rainwater goods, inconsistent colour schemes, alterations to doors, roof coverings and boundary treatments, and loss of chimneys and original ironmongery all erode the special character of an area. Reference to historic photographs of Dumbarton illustrate the extent to which this has already taken place: for instance, the large sandstone tenement at Nos. 84-92 High Street has been shorn of its street-facing wallhead chimneys and parapet balustrade, immediately reducing its visual impact.

Left: Nos. 84-92 High Street have lost much of the original architectural detail (© author); insert shows a datestone over the rear service entrance, salvaged from a far older building (© Jeremy Watson).
